THE CARDON MANAGEMENT GROUP

August 5, 2004

SUBJECT: Boom Hoist - Motor Vessel Leon I

July 1, 2004

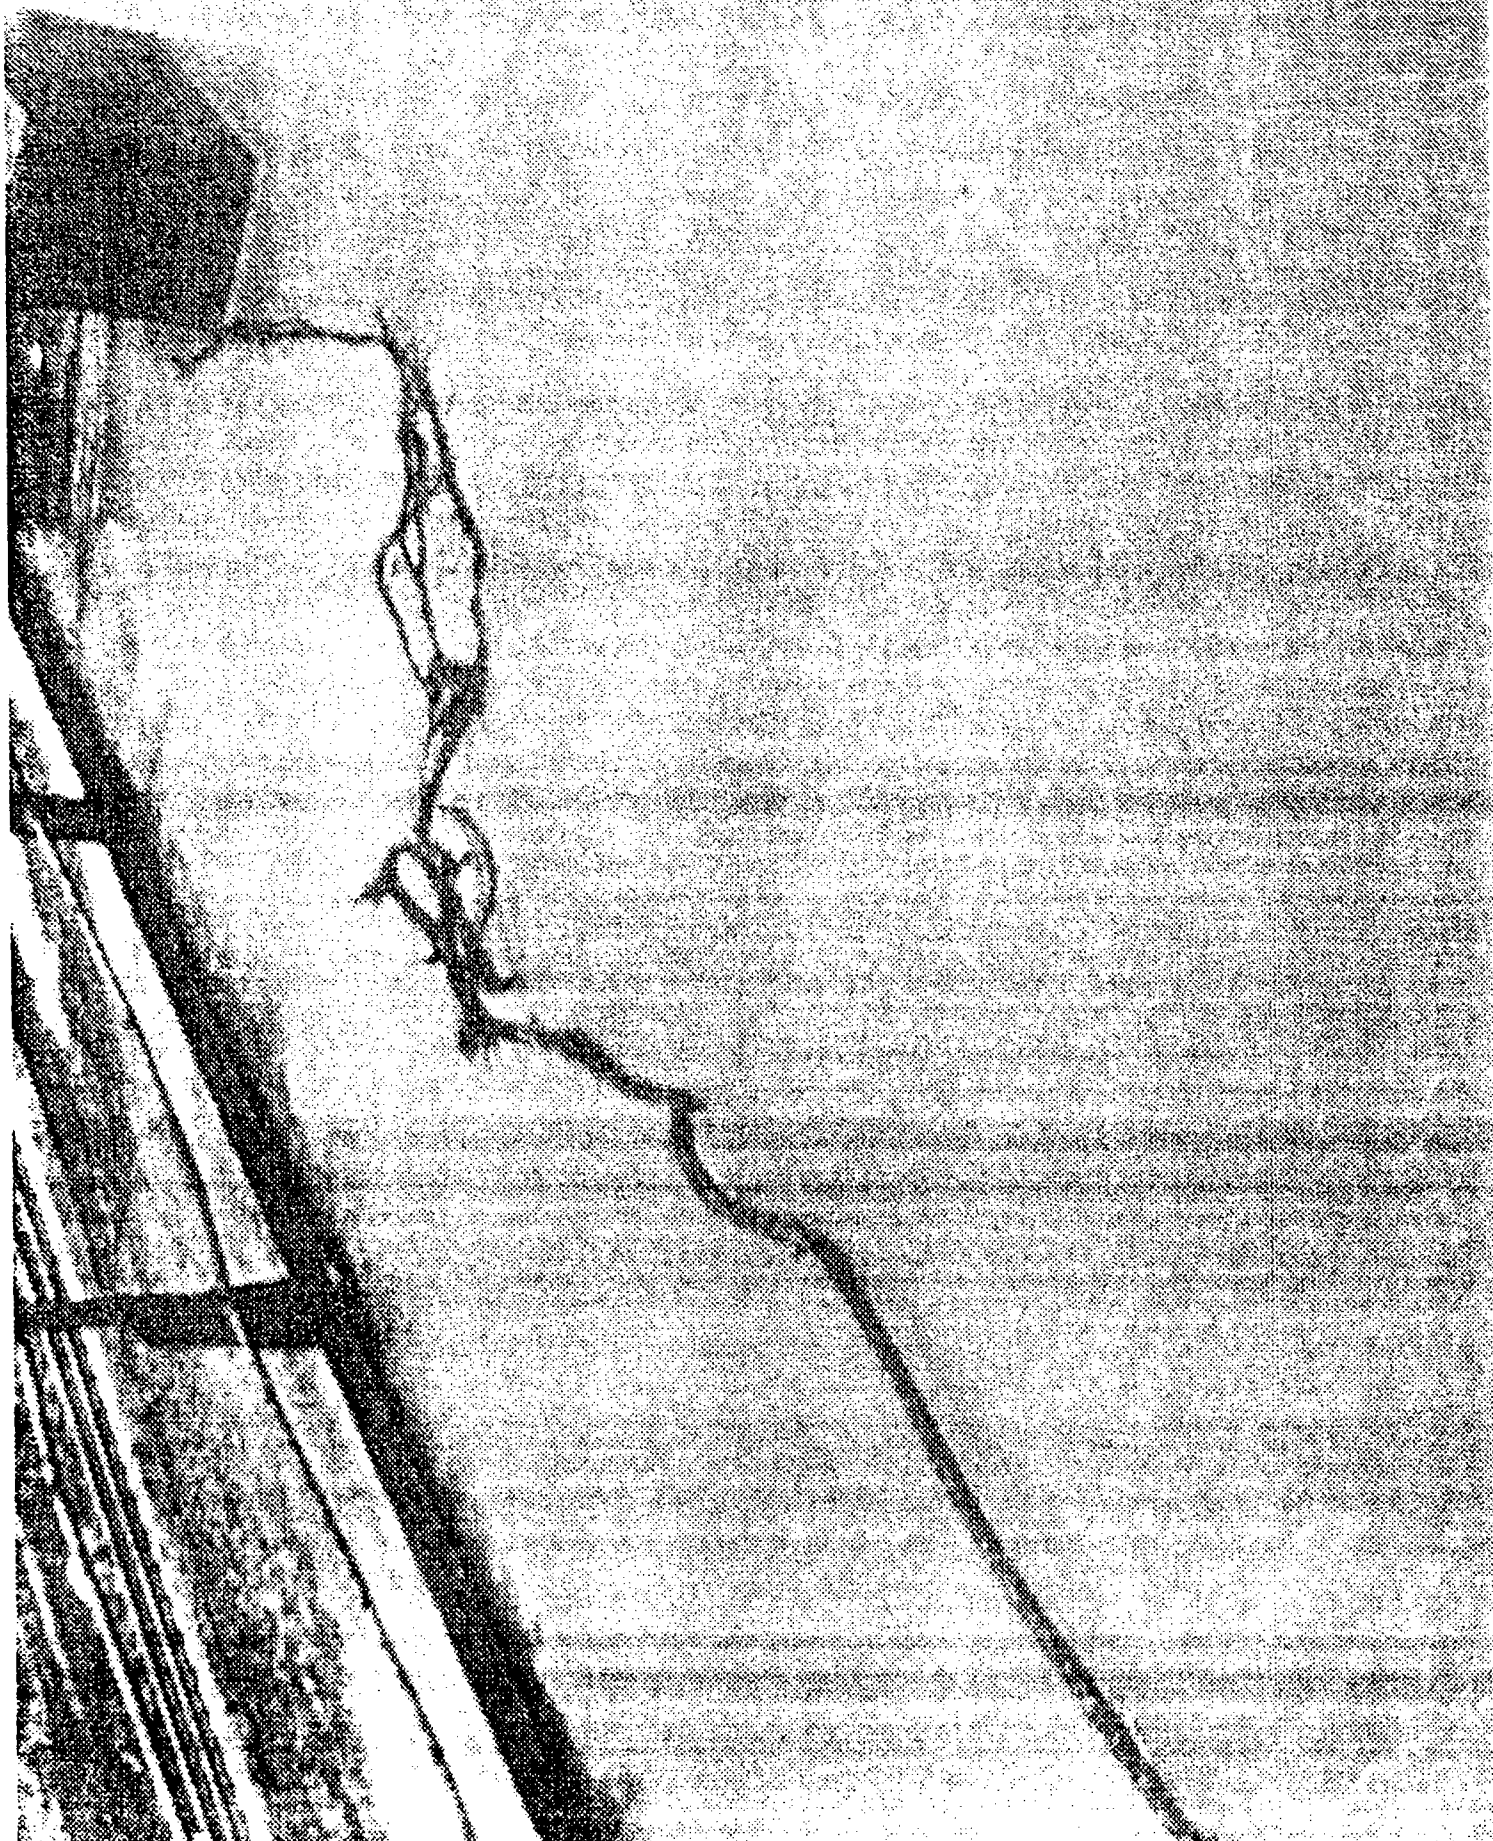
This photograph illustrates the post-accident condition of one end of the broken wire rope at the point of failure, displaying the severe corkscrew-like distortion of the wire rope. The appearance of this kind of extreme mechanical damage is ample demonstration that the wire rope was trapped and forced to bend while under tension over a very small radius at this point.
